DAMP IN INSULATION LAYER (INTERSTITIAL CONDENSATION)

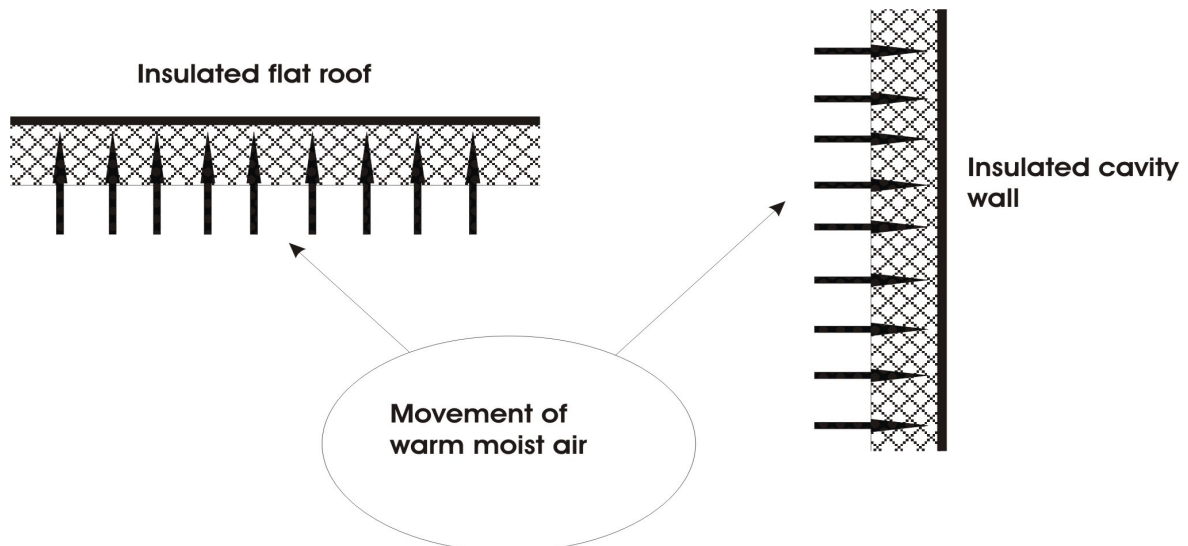
- Warm moist air from inside a building penetrates an insulated wall or roof and meets a cold surface.

- Leads to rotting of timber or rusting of metal frames and can cause structural damage.
- Increased risk in:
 - buildings with flat or pitched roofs with insulation between timber joists or rafters;
 - timber framed walls with insulation within frames, between internal plasterboard and external cladding;
 - insulated 'dry lining' of solid walls;
 leading to saturation of insulation which becomes ineffective.
